Job ID: 30285  
 Client: Swan Hill Rural City Council  
 Title: Swan Hill Comment Collection - Southern Package

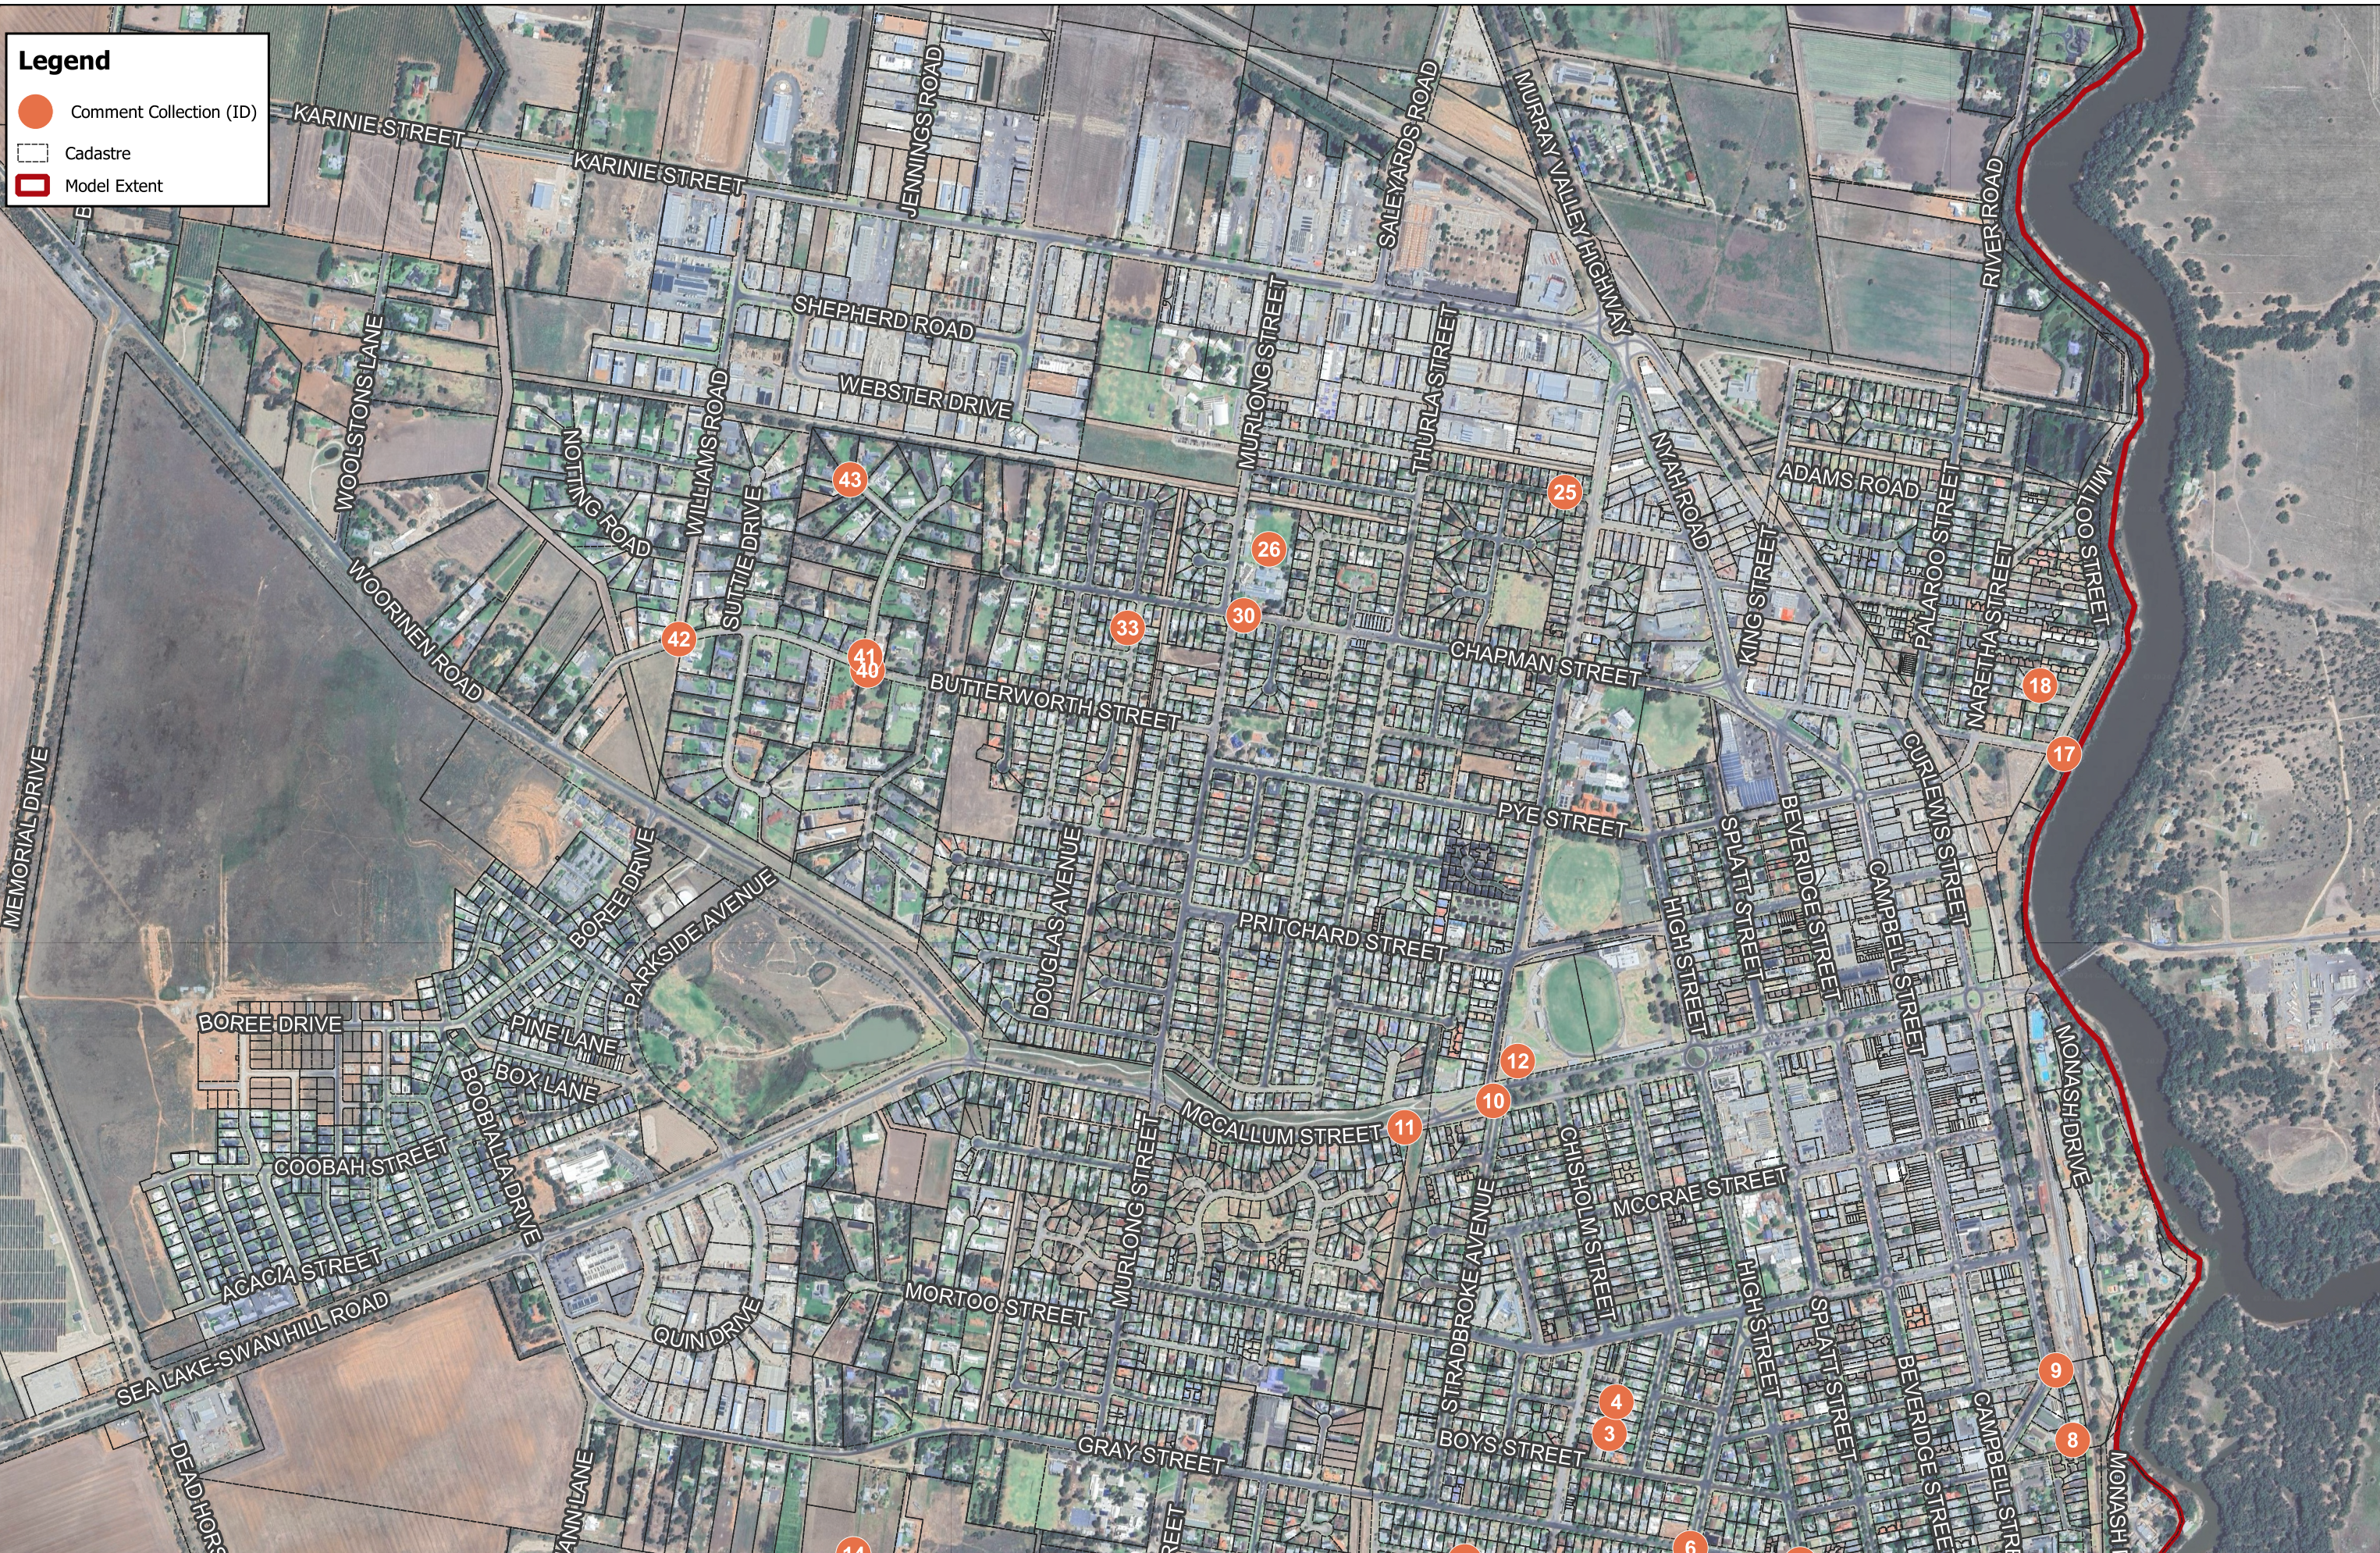
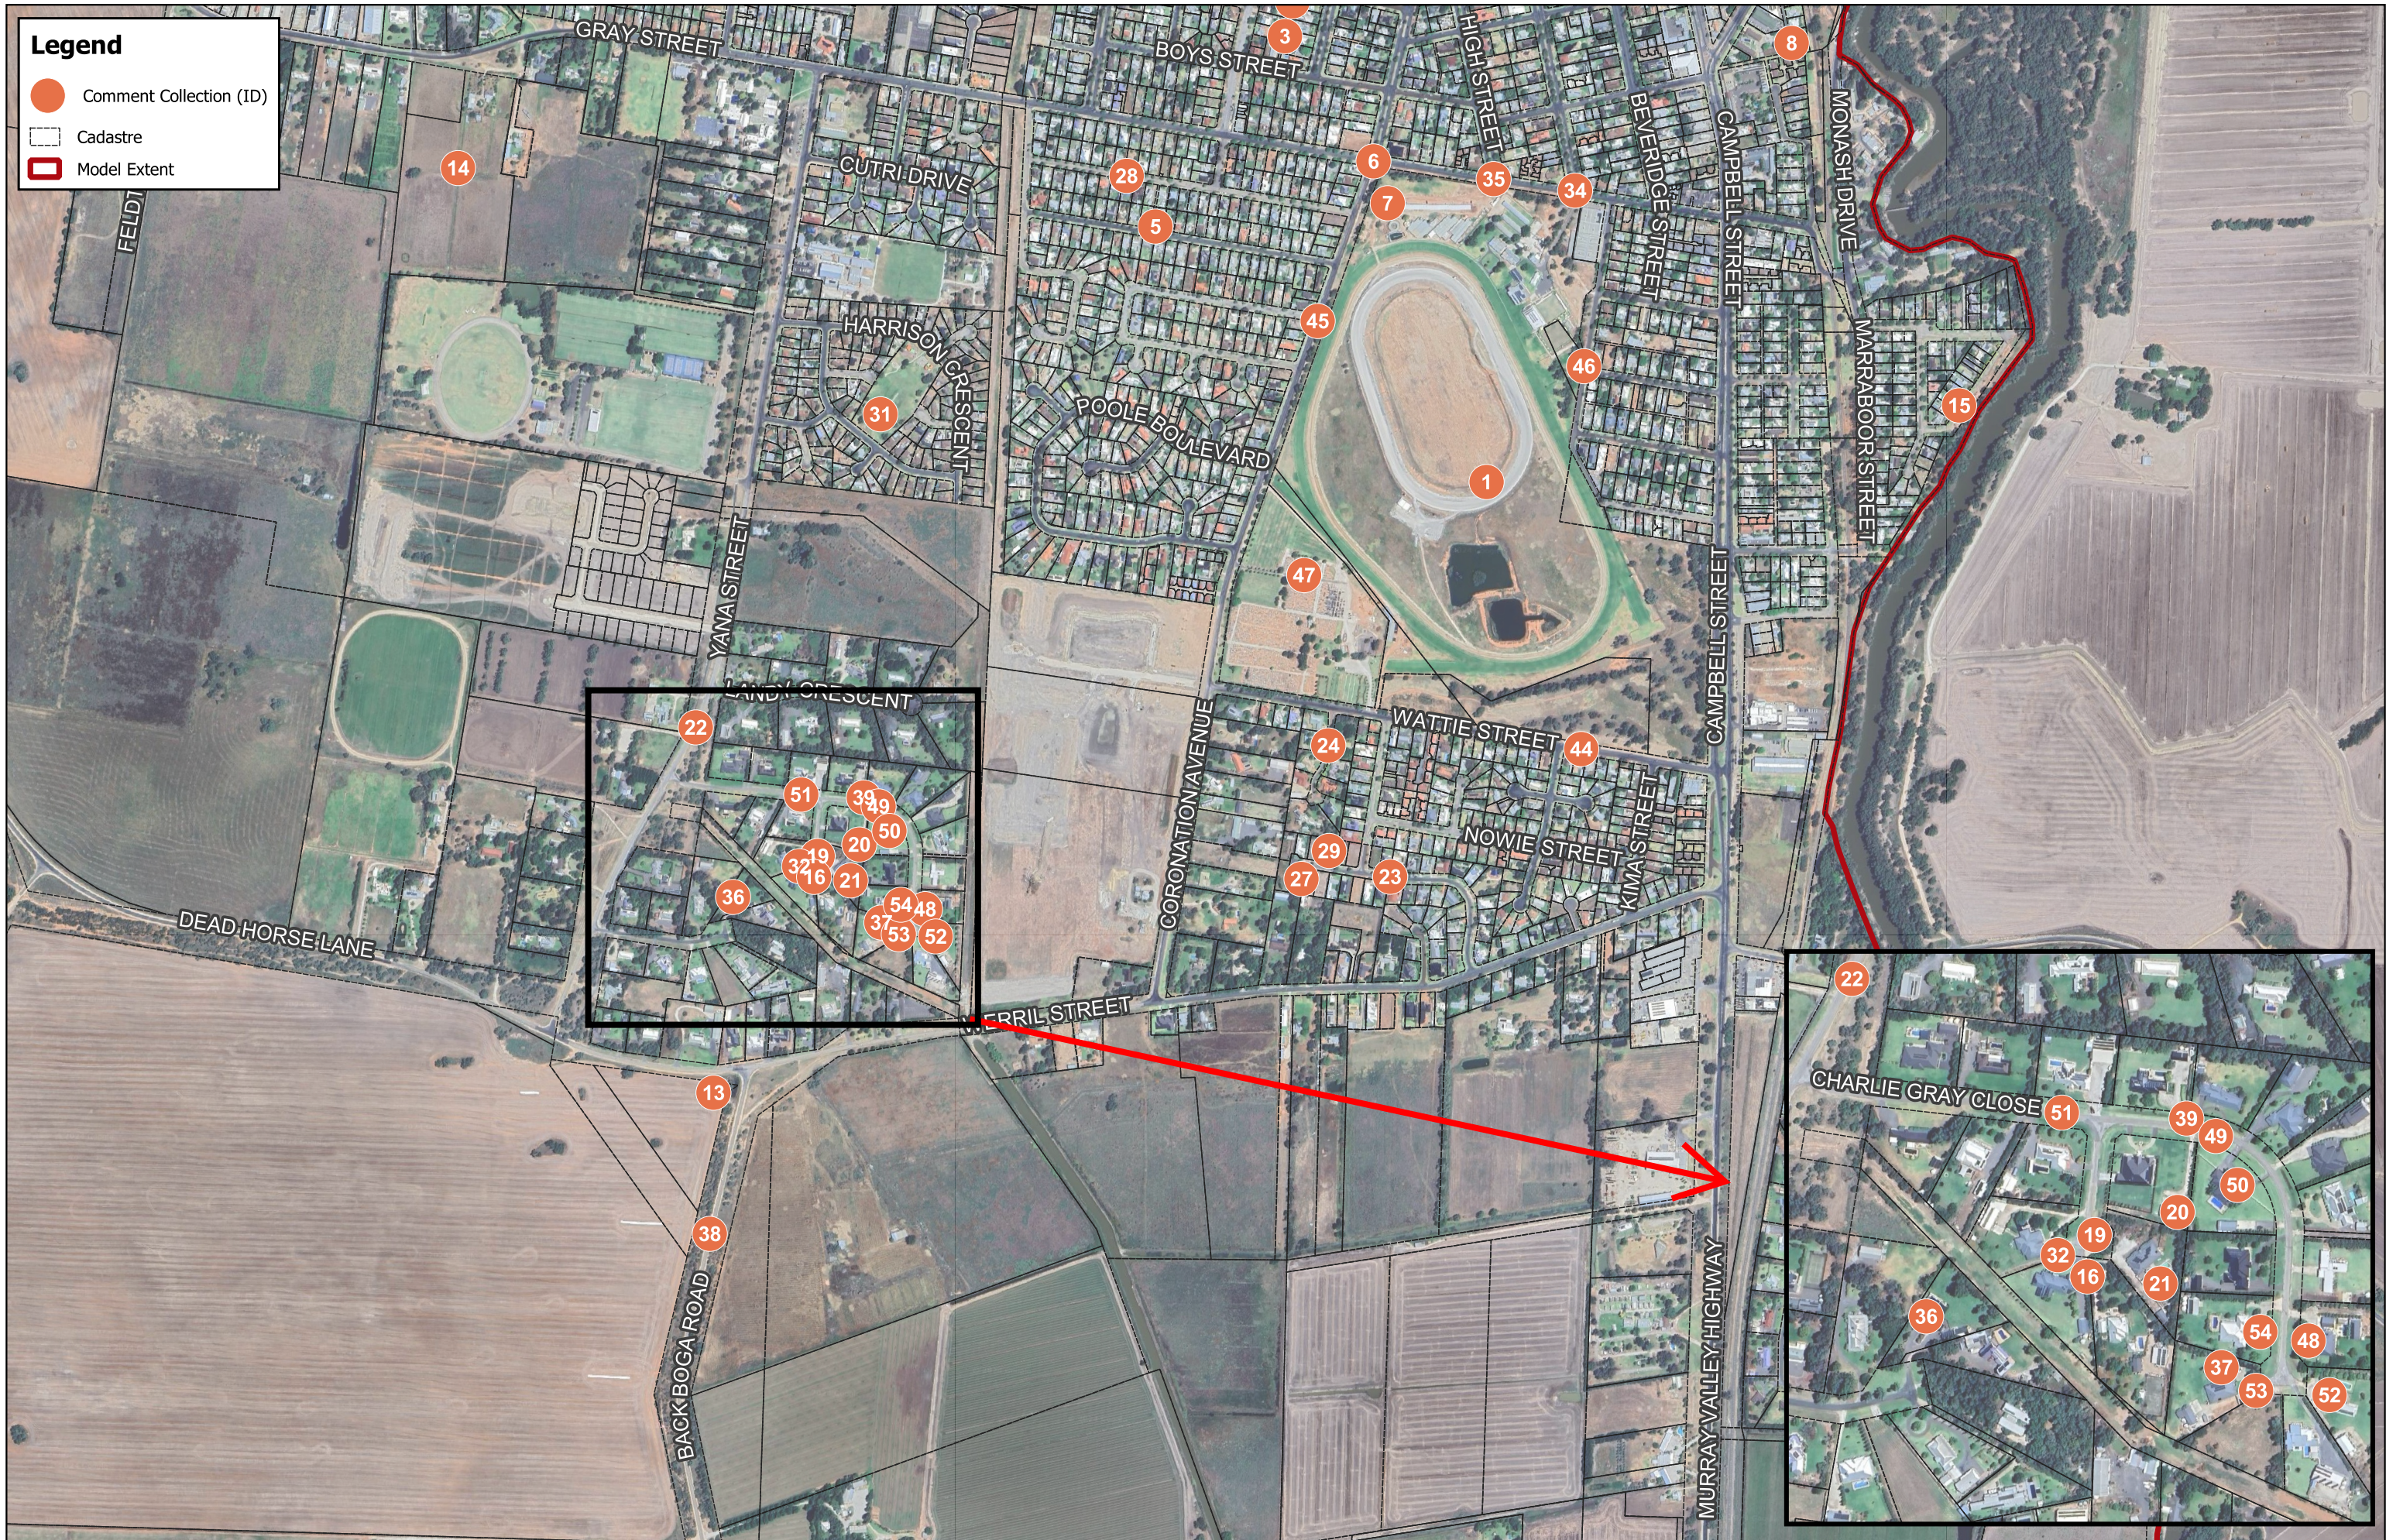
| ID | Community Comments |
|---|---|
| 1 | A solution is to use the Racecourse Reserve as a retardation basin to relieve pressure on the drainage system. Stormwater can be diverted there instead of flooding streets. Kerb and channeling on Coronation Ave's east side can capture and redirect water |
| 2 | Water accumulates here, no adequate drainage in storm events |
| 3 | Water cannot flow into the boys street due to the recent develeopments work. water sit more than a month and cannot drain out |
| 4 | Water flow from east to west and ponding in these two locations. overflow into the western properties . |
| 5 | Water sit at here, passing through the property. In January 2022, 50mm water depth at the street and the water raise in 20 mins, the drain out quickly in 30mins. Sag in Burton St, overland flow comes down Coronation Ave and Burton then floods No. 28 and 30 Burton. Suspected lack of drainage capacity upstream. |
| 6 | Water cannot flow to the west, since the gray street aroundabout is higher |
| 7 | Driveway redevelopment cannot flow into racecourse |
| 8 | Garage at this location got flooded Dec 2020, around 200mm high. Water flows from east to west, spreading along the railway but does not overtop the railway. Railway Avenue has small, flat pipes. All runoff from Railway Ave relies on a small inlet pit on the corner. Floods nearby homes. 13 Railway Avenue used to function as overland flow flood storage when the block was vacant. Now the block has been developed, which has made drainage worse. |
| 9 | No fall for the pipeline |
| 10 | Water pools at this roundabout |
| 11 | Bridge is the high point in the road reserve, water flows to the east of this location. |
| 13 | Basin/dam that is usually full. This location on Werril Street is a sag in the road. Runoff accumulates at the sag but cannot drain through the pipe under the road because the basin is always full. Floods the front yards and driveways of two houses. |
| 15 | Pump either fails or has insufficient capacity for larger storms. No other substantial drainage available. Local sag fills with water and regularly floods No. 16's shed and No. 18. |
| 16 | Lower houses suffer more due to natural drainage. Residents miss work to manage contaminated floodwater from septic tank issues. Pumping between nature strips impedes traffic, and the new Heirloom estate removed our pumping options. |
| 17 | Pump either fails or has insufficient capacity to drain the adjacent storage. Results in water backing up through the pipes to Milloo Crescent and flooding the street. |
| 18 | After floodwaters back up through pipes and flood Milloo Cres, water spills out of back yards and flows into the units immediately north |
| 19 | No stormwater drainage on Settlers Court, floodwaters accumulate and do not drain away. Residents have to organise their own pump hire in storm events to remove the water. The former channel they pumped to has been decommissioned |
| 20 | Charlie Gray Close has no drainage. Water accumulates in southeast Corner of 8 Charlie Gray Close |
| 21 | Stormwater has nowhere to drain and fills the yard of No. 2 Settlers Court. |
| 22 | Ponding of water reported on Yana Street between Landy Crescent and Charlie Gray Close |
| 23 | Nalder Drive reported to have stormwater drainage issues. |
| 24 | Frequent flooding of Sebastion Close reported (3 times in 2 years) |
| 25 | Stormwater drain underneath Mulbar Street reportedly caved in |
| 26 | Frequent flooding issues at Swan Hill North Primary School. Suspected insufficient capacity of pipe network in the vicinity. |
| 27 | Regular flooding of Nalder Drive road reserve. Residents unable to get out of their driveways. |
| 28 | Reported regular flooding of Donnington Street. Suspected clogged gutters, potentially pits. |
| 29 | Floodwater on road and driveway reportedly prevents residents from leaving No. 32 Nalder Dr. |
| 30 | Regular flooding of Chapman Street often prevents school attendance at Swan Hill North Primary School |
| 31 | Fills with water during rainfall event. Reportedly worsens mosquito issues in the vicinity |
| 32 | Formal drainage is needed for our estate. We've faced significant flooding multiple times in the past 15 years. Development rules allowed larger blocks, shifting costs to residents, leading to higher home insurance. |
| 33 | Street mains regularly full resulting in house drains and toilet frequently slow to drain. Photo and BOM data submitted to evidence even 1mm rainfall days result in pooling on road. |
| 34 | The intersection of Gray and Splatt has a deep gutter that nearly bottoms out cars when turning onto Splatt. This requires a very slow turn, which is dangerous if another vehicle is approaching. A culvert arrangement would allow for a smoother turn. |
| 35 | The intersection of Gray and High St has a deep gutter that nearly bottoms out my car when turning onto High St. This requires a very slow turn, which is dangerous if another vehicle is approaching. A culvert arrangement would allow for a smoother turn. |

| 36 | My neighbor drained black water into my yard due to severe flooding. A possible solution is building a pond in the nearby nature reserve to store stormwater for pumping when needed. |
| 37 | Every heavy rain floods yard and threatens house. |
| 38 | Back Boga Road- a natural point of water when there is a wet period, high rain event. Suggest this is enhanced and expanded to be Water Sensitive Urban Design- wetland- ephemeral, Green open space. Habitat. |
| 39 | Charlie Gray Close has no stormwater system. They flood often, and kids swam in 600mm of water on Christmas 2023. Residents note they have been on the 10-year plan for 15 years. |
| 40 | Water accumulates and does not drain. Existing pit and pipe network does not remove water. Once when the pipes and pits were unblocked following a flood event, the pits successfully drained the stagnant water. Suspected blocked/damaged pits and pipes. |
| 41 | The corner drain is currently full of sludge. There are issues with flooding at Butterworth Street and Berrybank Drive and adjacent properties which will not be resolved with the improved drainage if drain maintenance is not enforced. Some of the road verges in both Butterworth St and Berrybank Drive do not drain into a drainage system and water remains in the verges, all the verges should be surveyed so they drain effectively |
| 42 | The existing drain on the corner of Butterworth & Berrybank is the main water collection point and there should be additional drainage points between Berrybank Drive and Williams Rd to collect the water before it gets to Berrybank Butterworth intersection |
| 43 | The court of Yvonne Close should also have a drain. |
| 44 | Regularly floods with heavy rain events |
| 45 | Regularly floods with heavy rain events |
| 46 | Regularly floods with heavy rain events |
| 47 | Regularly floods with heavy rain events |
| 48 | After severe rain events the front and back yards as well at the rear of the shed fills completely with water for days. |
| 49 | The compulsory installation of drains under all crossovers has worsened the situation, allowing water to drain freely to one end with no outlet, leading to flooding in certain houses. |
| 50 | There is concern about stagnant water in the table drains, leading to health risks with the septic tanks. The property retains the most water, and the table drains fail to drain it properly. |
| 51 | Infrastructure installed after the 2011 floods has provided little relief. During the 2022 floods and heavy rains in Christmas 2023, the property was inundated, with no ability to pump excess water away. |
| 52 | Most water migrates from the drains at the western end of the estate to the east/south and ends up at the very end of Charlie Gray Close |
| 53 | At this end it builds up and breaks out of the drains and floods the front yards of numbers 14 and 16. 16 in particular has had multiple events where the house was nearly flooded and was only saved by local and public intervention by pumping water out |
| 54 | When large storm events occur or when there is a prolonged wet period which causes the ground to be saturated the drains will still reach capacity and there is nowhere for the water to go. It either breaks out of the drain and causes a flooding risk |
